NSWCCD-TR-61—97/10

Survivability, Structures, and Materials Directorate
Technical Report

SEM Stereo-Section Fractography Observations

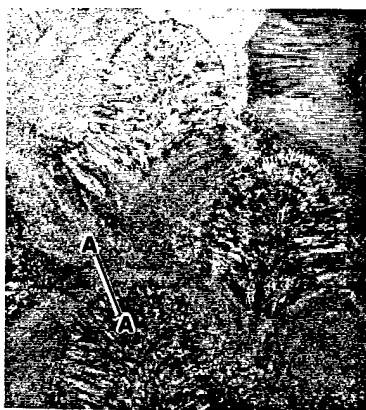
Figure 8a illustrates the weld bead microstructure of specimen G XK 62. The microstructure surrounding the fusion line of one bead (A-A in Figure 8a) has been magnified in Figure 8b. In this picture, the FGHAZ, CGHAZ, fusion line, and the edge of the CCZ are evident. It is important to note the similarity between the CGHAZ and the edge of the CCZ adjacent to the fusion line: both contain allotriomorphic ferrite along the prior austenite grain

Figure 8a: The weld bead structure of specimen GXK 62.

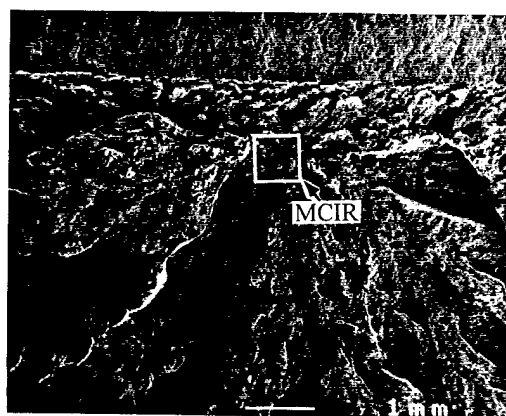
The SSF results indicated that the MCIS in four of the five sectioned GXK specimens was located at the edge of the CCZ, adjacent to the fusion line. Specimen GXK 62 is typical of these specimens. The unsectioned fracture surface of this specimen (Figure 9a) clearly indicates the dominant CIS. The focal point of the site (within the white box in Figure 9a) is enlarged in Figure 9b and the cleavage initiation site has been identified by the black arrow. A transverse section was then prepared approximately 10 μm from the cleavage initiation site. Figure 9c shows the fracture surface and transverse section simultaneously after tilting the specimen 45° about the sectioning axis. In the figure, the small triangular cleavage facet near the cleavage initiation site (indicated by black arrow) was used to identify the location of the MCIS as the section was rotated to view solely the transverse microstructure surrounding the CIS and fatigue precrack (Figure 10). It is evident in Figures 9c and 10 that cleavage initiation was associated with long ferrite plates at the edge of the CCZ, adjacent to the fusion line. Further, it is evident that (1) the tip of the fatigue pre-crack was located in the middle of the CCZ; (2) ductile crack growth proceeded through the CCZ for approximately 1 mm without triggering cleavage cracking; and (3) cleavage was triggered only when the edge of the CC microstructure was sampled by the crack tip. As mentioned earlier, four of the five GXK specimens examined also exhibited cleavage initiation only within the CCZ, near the edge of the fusion line.

Figure 9a: A low magnification conventional SEM fractograph of specimen GXX 62.

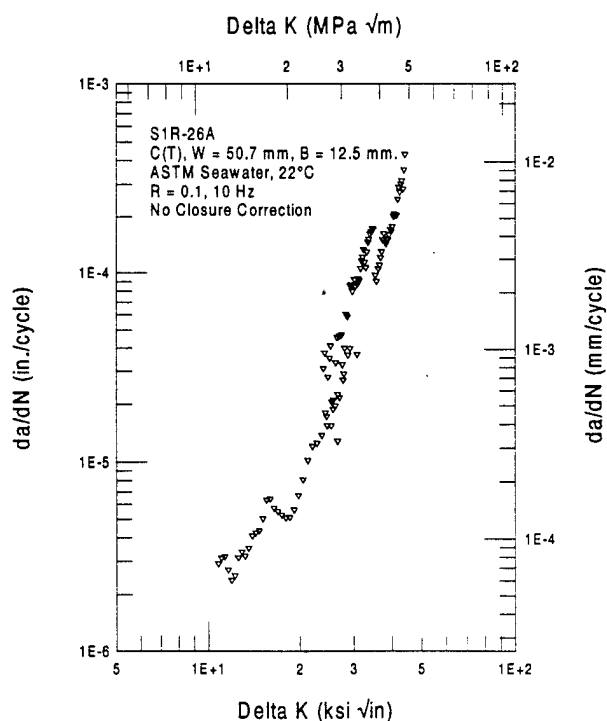
Figure 12

The SSF technique was also applied to study the cracking behavior of a Ti6Al-4V forging. This material was tested in 3.5% NaCl at room temperature under constant amplitude, $R=0.1$ loading. The fatigue crack growth rate (FCGR) behavior was highly nonuniform and exhibited sporadic crack growth acceleration and deceleration, especially between $10 \text{ MPa}\sqrt{\text{m}} < \Delta K < 20 \text{ MPa}\sqrt{\text{m}}$ (Figure 12). Fractographic observation revealed three distinct features on the fatigue surface which contribute to this behavior (Figure 13a): (I) coplanar faceted regions; (II) brittle, randomly-oriented faceted regions; and (III) peculiar transverse regions featuring crystallographic facets and out-of-plane steps or jogs. An enlargement of one of these areas (Figure 13b) illustrates one of the peculiar surface feature III regions.

Figure 12: Fatigue crack growth rate behavior of Ti6Al4V forging: specimen SIR-26A.

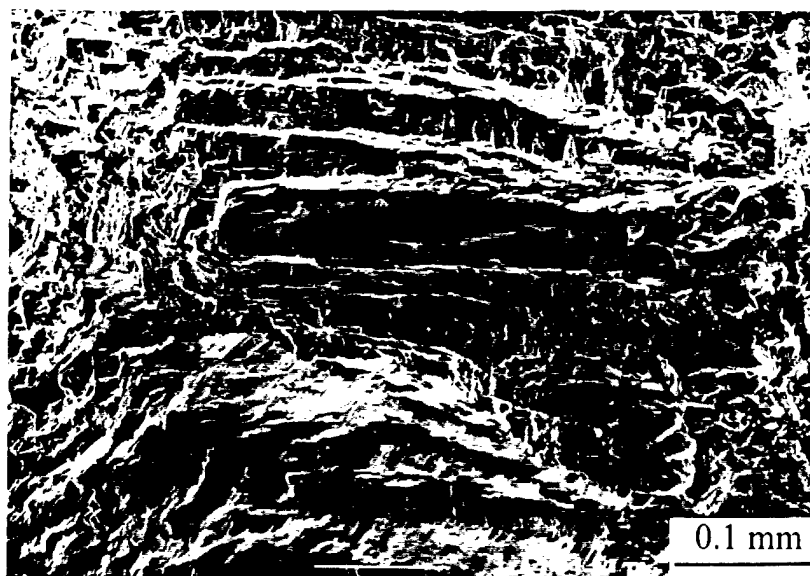
Figure 13b. An enlargement of the boxed area in Figure 13a.

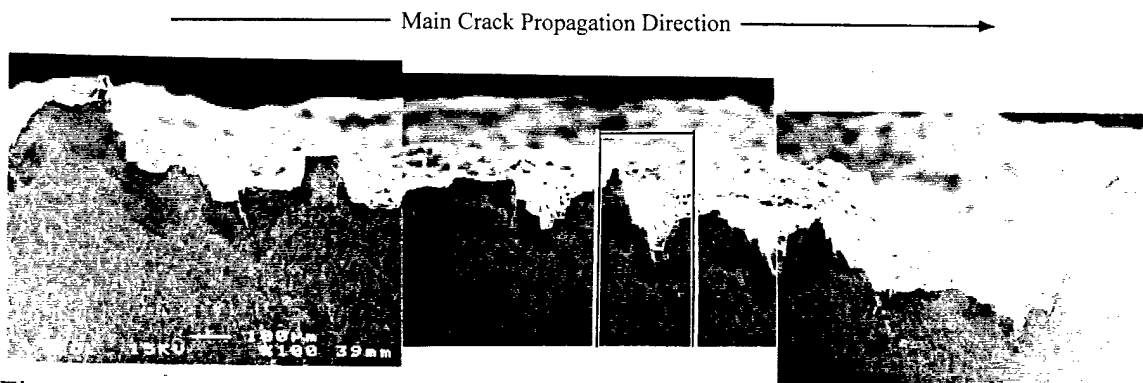
The SSF technique was again utilized to examine the usual transverse section (Figure 1) through a feature III region. These sections are revealed in Figures 14a and 14b and the acuity of these ledges becomes apparent; each is on the order of 100 - 200 μm out of the fracture plane. Closer examination of one of the troughs reveals extensive out-of-plane cracking that follows elongated α grains. A second SSF section was made perpendicular to the section in Figure 14b (section A-A) near the trough illustrated in this figure. The transverse cracking path is now clearly shown to propagate along elongated α grains with a preferred orientation (Figure 14c). An enlargement of the trough (boxed area in Figure 14c) illustrates the coplanar nature of this cracking as shown in Figure 14d. The top-most plane is evident in the bottom portion of Figure 14d and is actually the polished and etched microstructure of section A-A (Figure 14b). The layers below this plane are the fracture surfaces of the secondary cracks that appear to the left of section A-A (Figure 14b). The correspondence between the crack surfaces and the microstructure is striking and indicates the crystallographic nature of this cracking, the relative weakness of this orientation, and the strong texture within this region.

Figure 14a: An optical micrograph of the transverse section through the feature III region shown in Figure 13a.

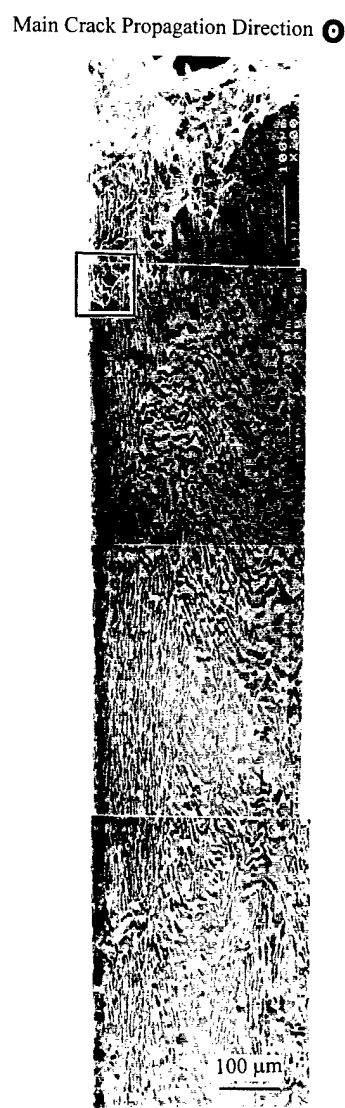
These pictures elucidate the correspondence between the secondary cracking path and the orientation of the elongated α grains. The α grain orientation texture was produced during the solidification process and was not eliminated by subsequent heat treatment. The crystallographic appearance of this cracking implies that a cleavage-type mechanism may govern this phenomenon. This out-of-plane cracking is not desirable because of both its brittle nature and the fact that it implies this microstructural orientation is much weaker than in the normal plane within these regions. The texture can be eliminated through proper solution heat treatments to form either randomly oriented, equiaxed α grains mixed with $(\alpha + \beta)$ constituents, or a fully transformed structure. A more homogeneous, isotropic, and stronger fracture performance should then be achievable.

Figure 14c: An SEM micrograph of the second SSF section along line A-A in 14b.
